70" TV can't show normally after OC replacement due to new open cell - verify & change the panel ID.

Affected Chassis: TPN20.6E LA

Info: Panda Open CELL CC700PV3D01 and T-CON were EOL, and switch to new one CHOT CELL CV700U2-T01. The new panel needs to change the panel ID to solve the problem TV can't display normally.

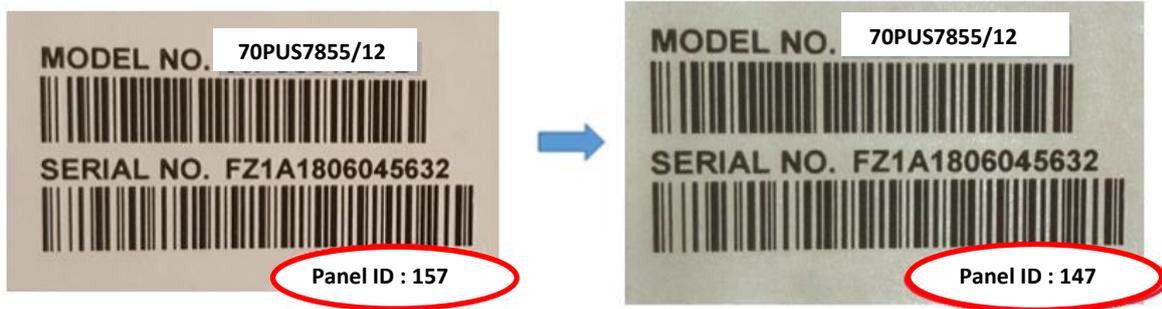
TPN20.6E

- 1 Change the panel ID
 - 1.1 Entering the factory menu "Menu +1999 + back"
 - 1.2 Changing the panel ID to 147
 - 1.3 AC off/ on
- 2 Update the Panel ID on the back cover label

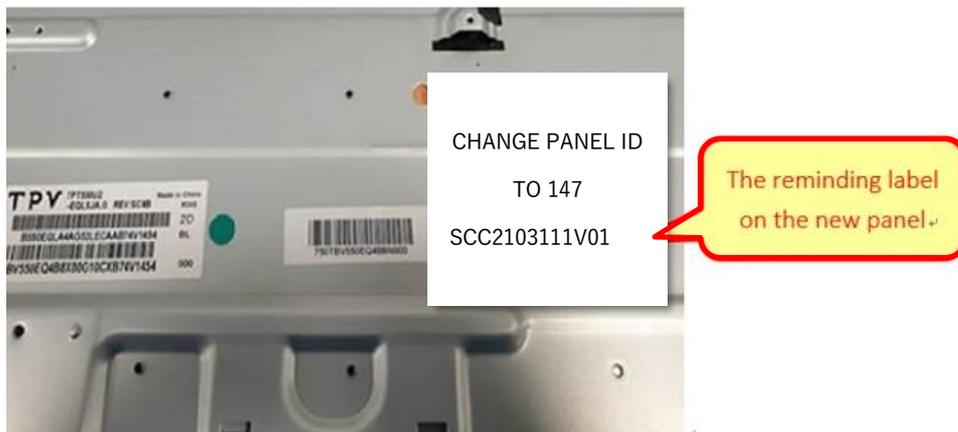
1. Chassis which support set option code programming (TPN20.6E): Please note that in case the set option code was entered (e.g. after SSB replacement) the panel ID is reset to original value -> double picture. Please change the panel ID again in the factory menu to the new value.
2. NVM update: After updating the NVM (e.g. after SSB replacement) the panel ID is reset to original value -> double picture. Please change the panel ID again in the factory menu to the new value.
3. SSB replacement: If new (pre-programmed) SSB is ordered, then it is pre-programmed with the original panel ID -> double picture. Please change the panel ID again in the factory menu to the new value.
4. Spare parts: The new panels 12NC and 18AC are not the same as the old ones. The new panel has a reminder label on the metal cover on the back (change the panel ID to 147).
